LOCK 3 DAM AT MECHANICVILLE

INVENTORY NO. N.Y. 215

PHASE I INSPECTION REPORT

NATIONAL DAM SAFETY PROGRAM

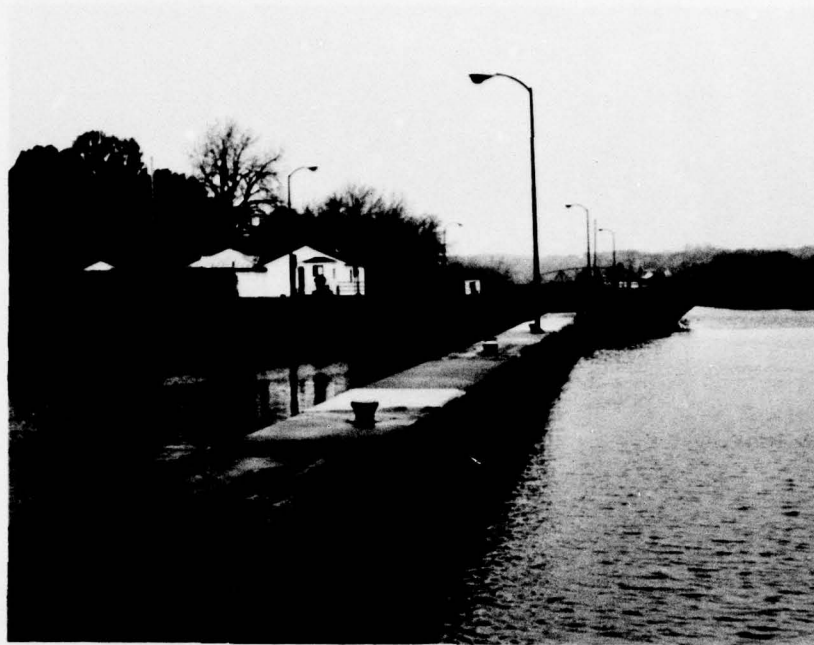
UPSTREAM APPROACH TO LOCK 3
